# Design Note

**DN#:** 041

**Re:** Correct operation of DEMI TR Sequencer

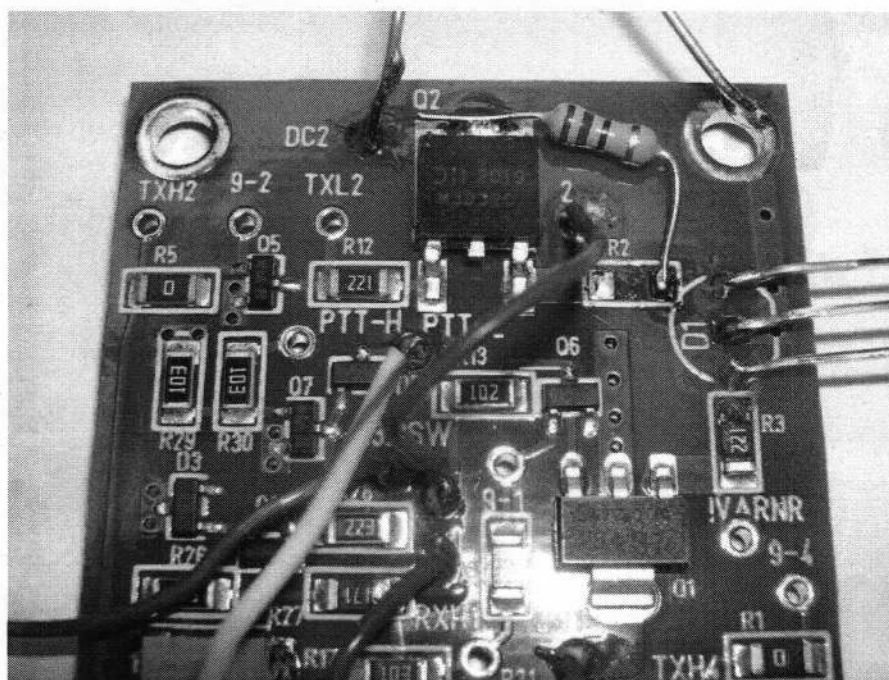
All other circuitry is good and will function as designed. Follow the document for the DEM TRS for further information. Pictured below is a modified Sequencer.

**THE MODIFICATION:** The modification is simple. First remove R2, a surface mount resistor. Install a leaded 220 ohm (1/8 or 1/4W) with on lead attached to the R2pad connected to the leg of the TX/RX Led, D1. The other lead is connected to the large Tab of the Q2 Transistor, or the collector. Then the +DC is supplied to the #2 via and the sequenced output of the switched circuit is supplied through DC2.
